PHASE I INSPECTION REPORT
NATIONAL DAM SAFETY PROGRAM

**COSTICH LAKE BASIN
COSTICH DAM
EUREKA, MONTANA
MT-1025**

**GLEN LAKE IRRIGATION DISTRICT
(OWNER AND OPERATOR)**

**MORRISON - MAIERLE, INC.
CONSULTING ENGINEERS**

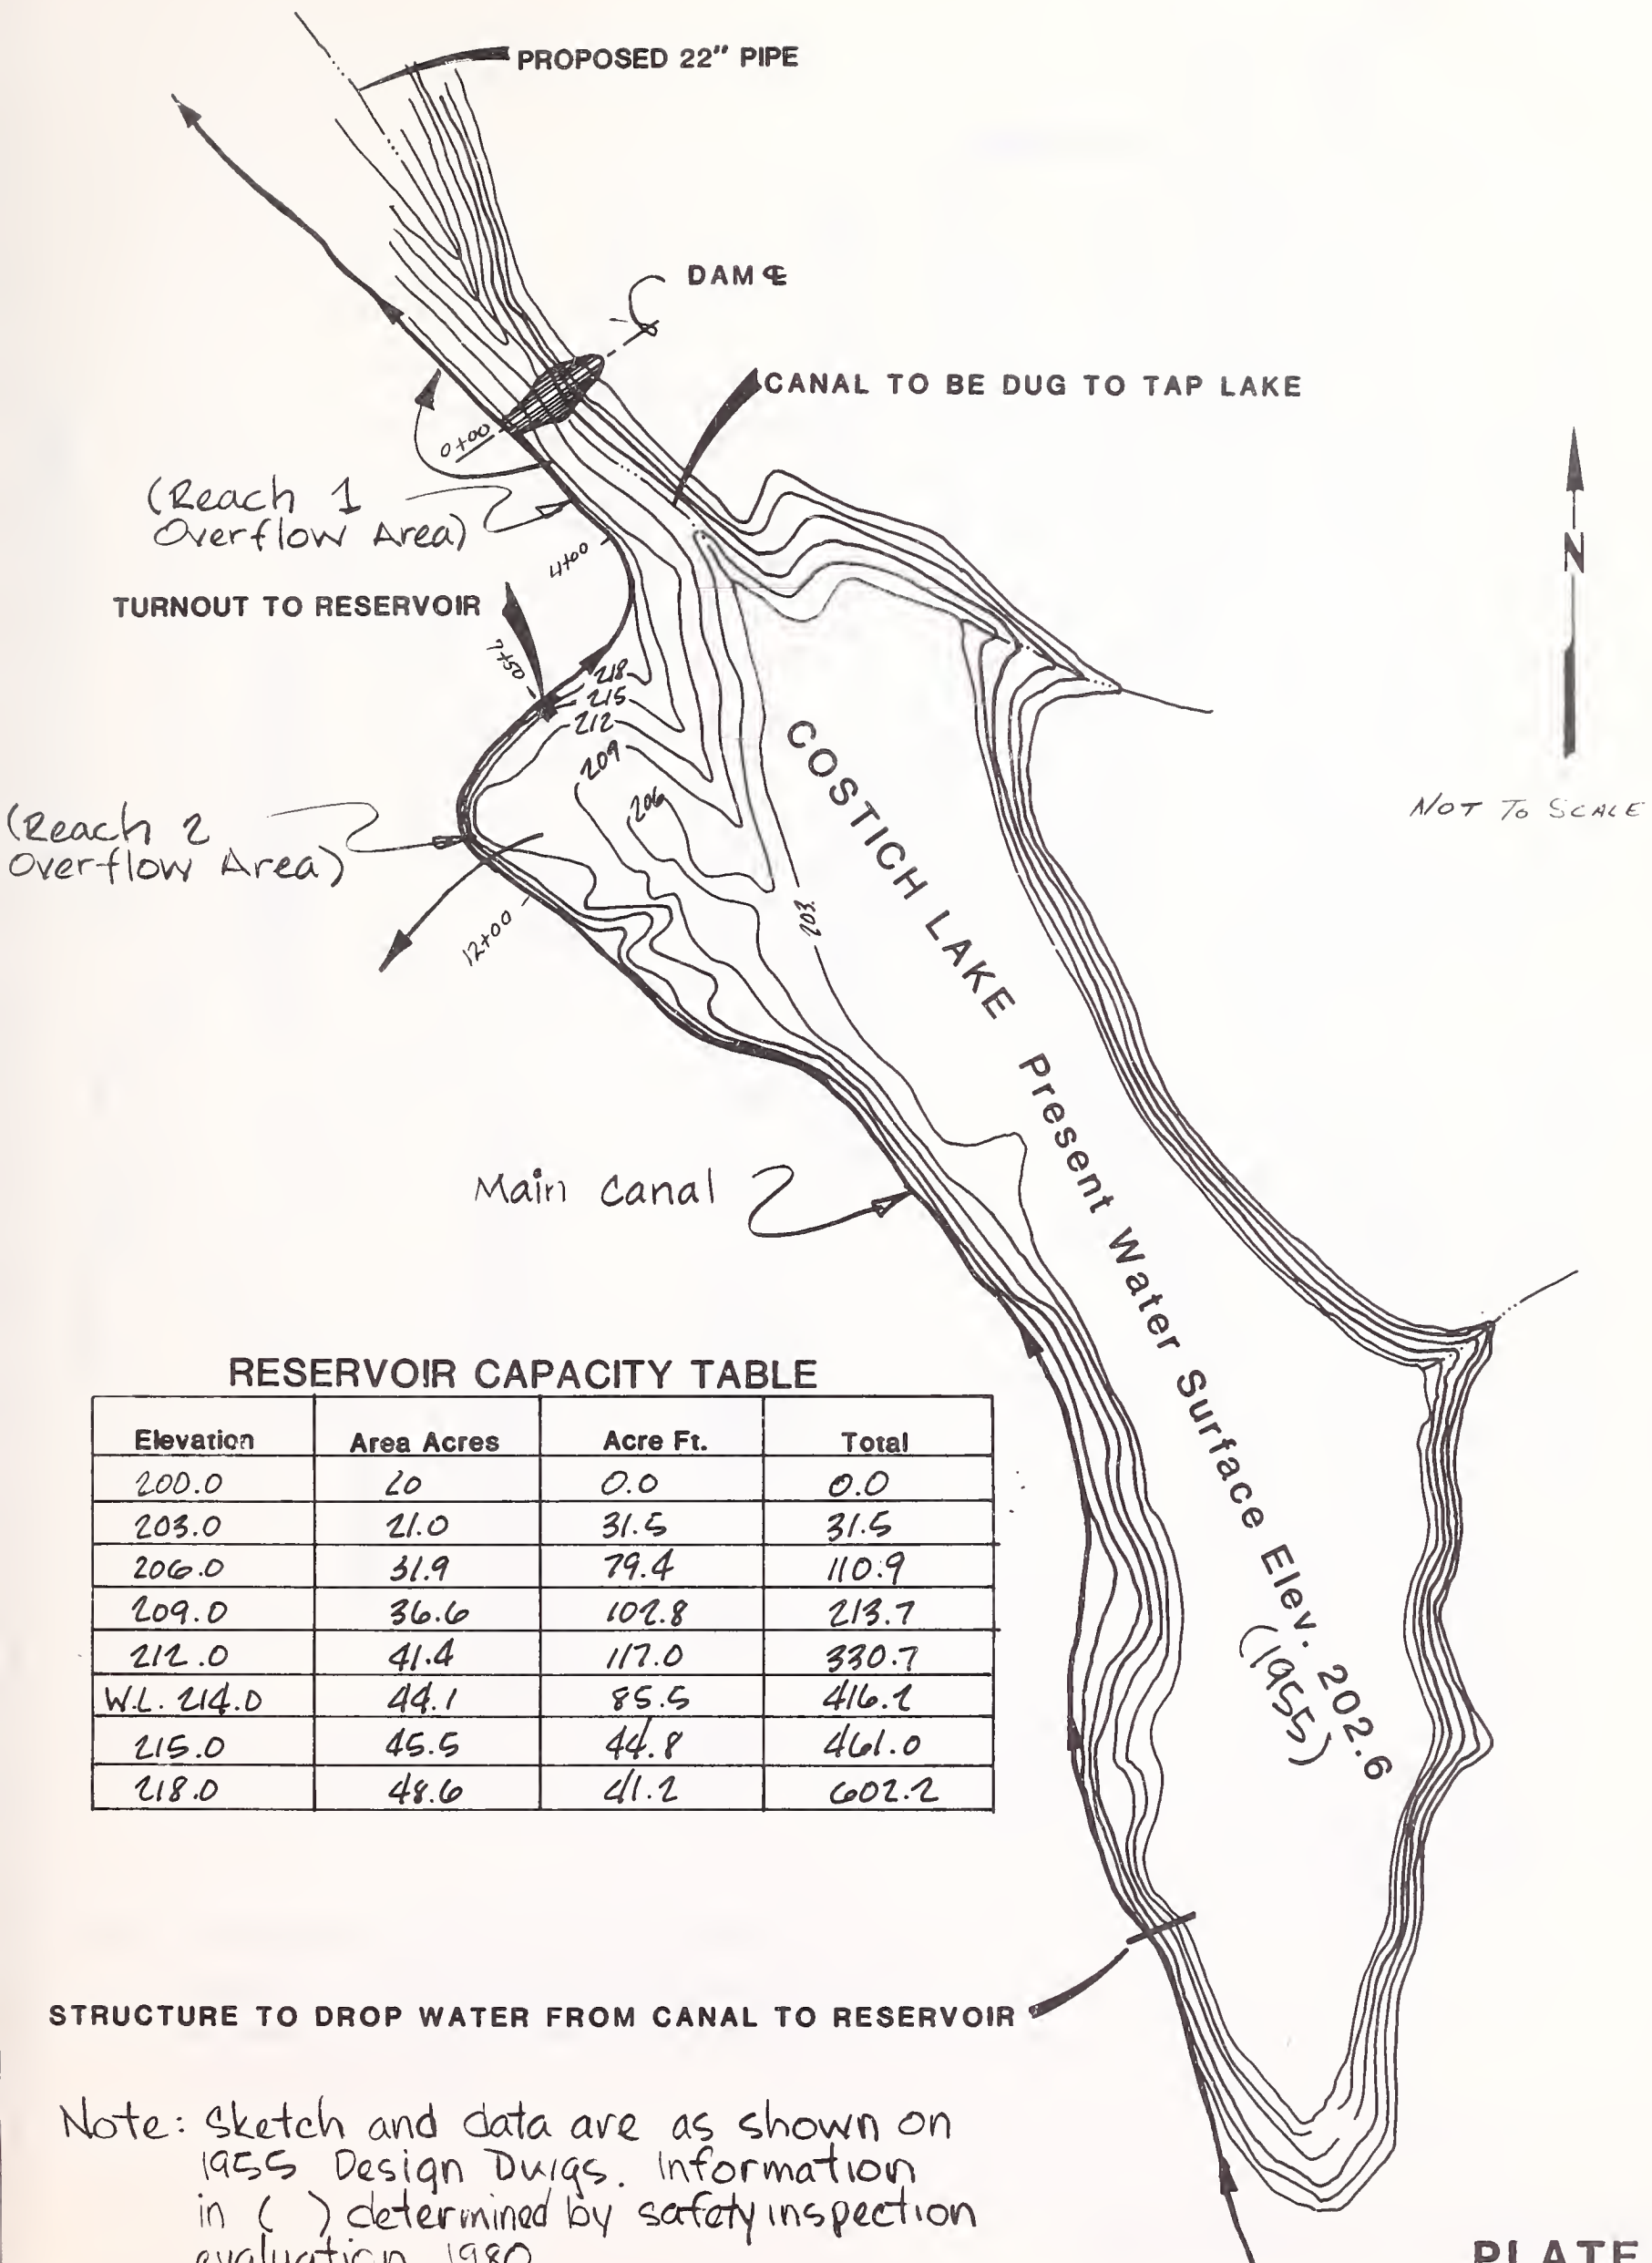
The foundations of the main canal also consists of glacial till. The downstream slope of the canal dike exhibits evidence of seepage near the toe of the dike from about Station 9+25 to Station 10+25 (plate 3). This area had very wet soil at the surface and was vegetated with sedge grass. The only seepage water observed was at the toe of the dike and was clear water. The seepage appeared to be confined mostly to the natural ground, i.e., the glacial till foundation under the dike and was possibly moving through the pedological soil zone at the top of the till foundation.

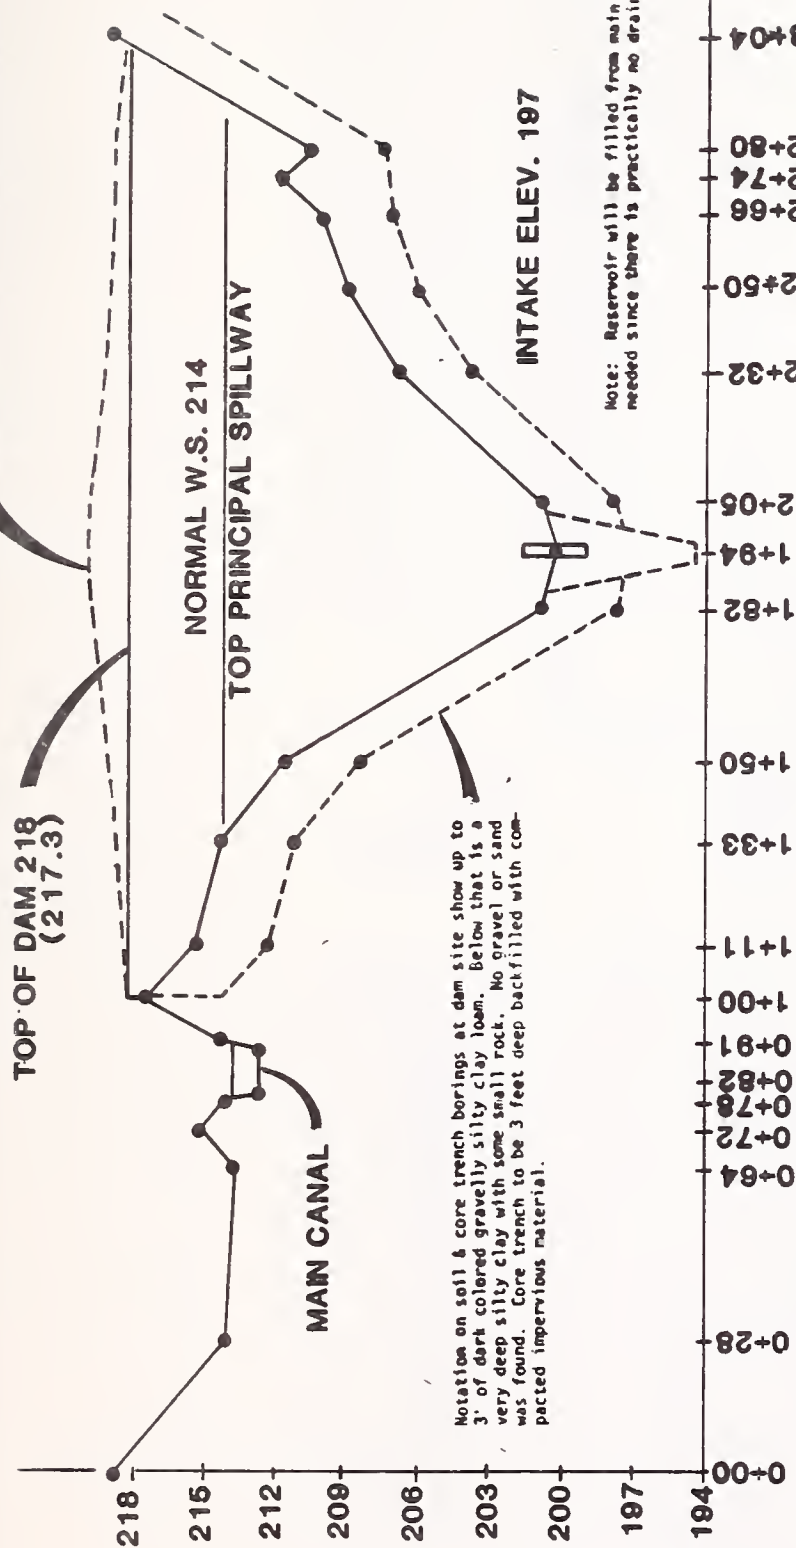
PLATE 4

The onsite inspection revealed that an additional embankment not indicated on the design drawings had been placed on the downstream slope of the dam. A personal communication with Mr. Walters, the area conservationist with the SCS, indicates the added embankment was placed as a lower bench to support an irrigation ditch which crosses the dam face. This ditch is not part of the Costich Dam project. It is not known if the bench was placed at the time of the original dam construction or at a later date. Mr. Walters first observed the dam in the early 1960's and the bench was in place at that time. Also, no details or information exist for the main supply canal, which forms a levee along portions of the west reservoir shoreline.

EXIST EMBANKMENT NOT SHOWN ON ORIGINAL DESIGN DRAWINGS

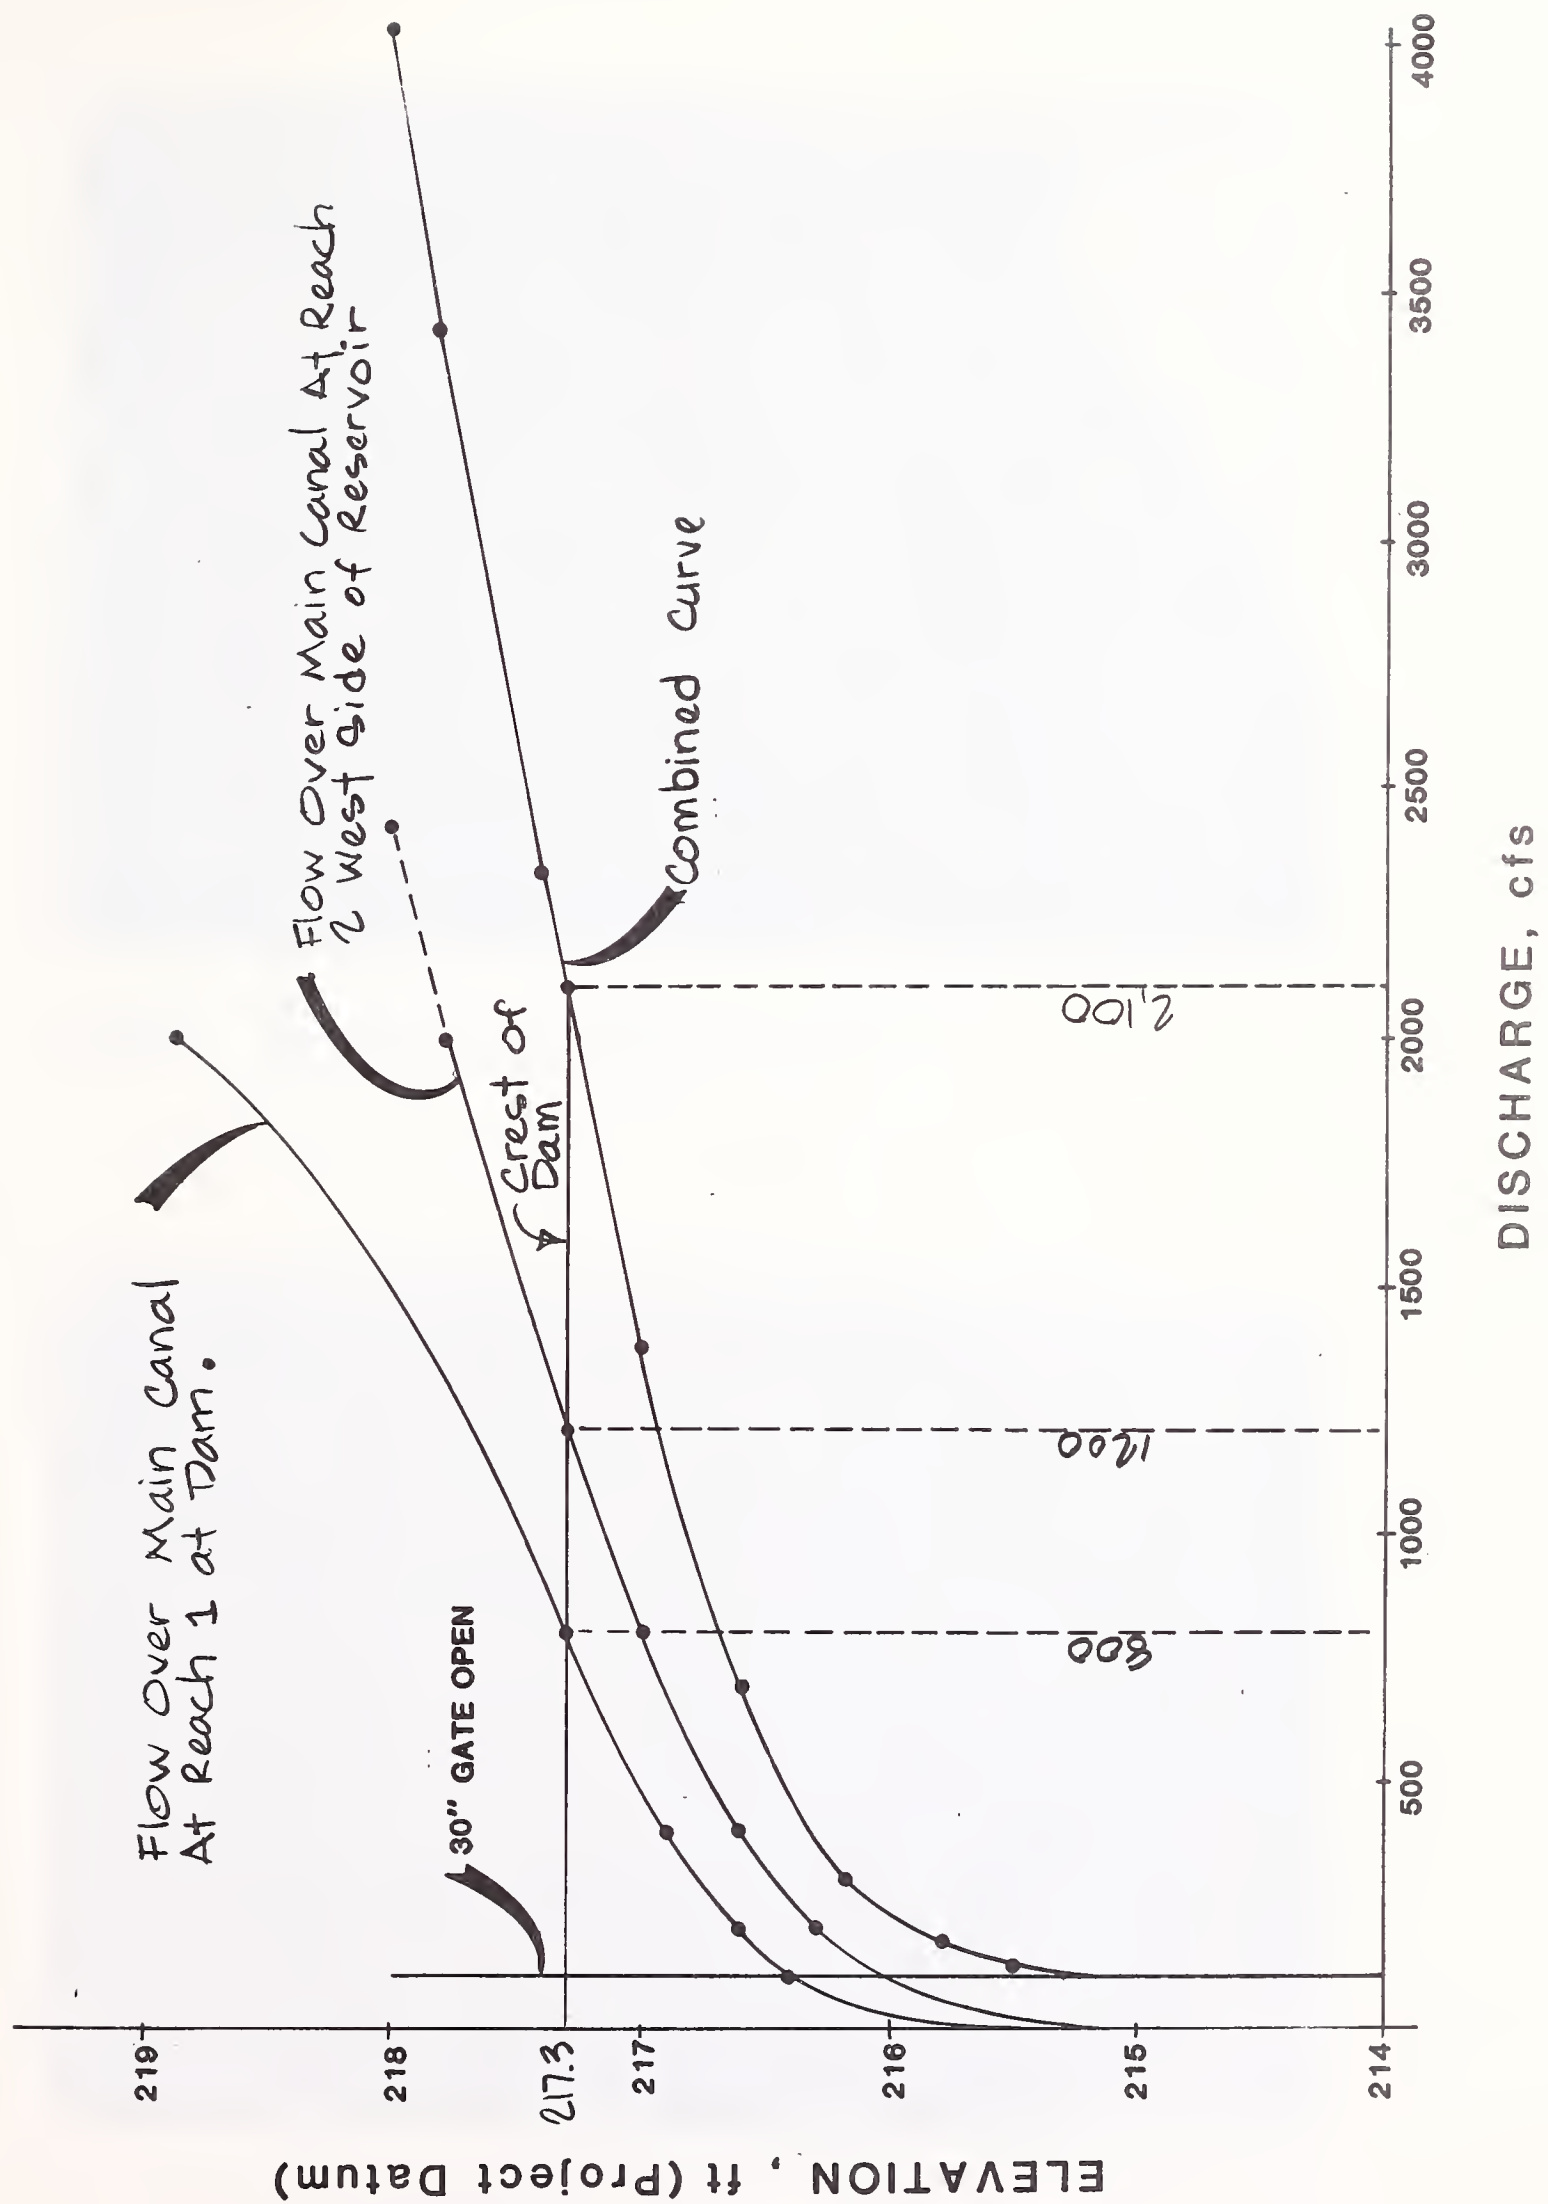
PLATE 5

A discharge rating curve for overflow of the first reach was developed assuming a weir overflow over the canal bank without bank failure although failure would probably occur. Flow in the overbank area around the dam was computed using a standard step backwater calculation (HEC-2, Reference 4). Using a Manning's "n" value of 0.032, the maximum overflow which would occur at the first reach of the canal was estimated to be 800 cfs with the reservoir at the top of the dam elevation 217.3 project datum. The elevation discharge curve for this overflow is shown on plate 5.

feet to over 217.0 feet project datum (elevation 2848.2 feet to 2850.0 feet NGVD). Flow overtopping the canal in this area (Reach 2 on plate 3) would discharge to a low depression area and down a separate drainage located immediately west of the reservoir. Flow over the canal bank in this second reach would not threaten the safety of the dam but would cause the main canal to erode resulting in the release of reservoir water down the west drainage. A discharge rating curve for overflow of the second reach was developed assuming a weir overflow of the canal bank again without failure. Using a Manning's "n" value of 0.032, the maximum overflow which would occur at the second reach of canal was estimated to be 1200 cfs. with the reservoir at the top of the dam elevation 217.3 feet project datum (elevation 2850.3 feet NGVD). The elevation-discharge curve for the overflow at the second reach of the canal is shown on plate 5.

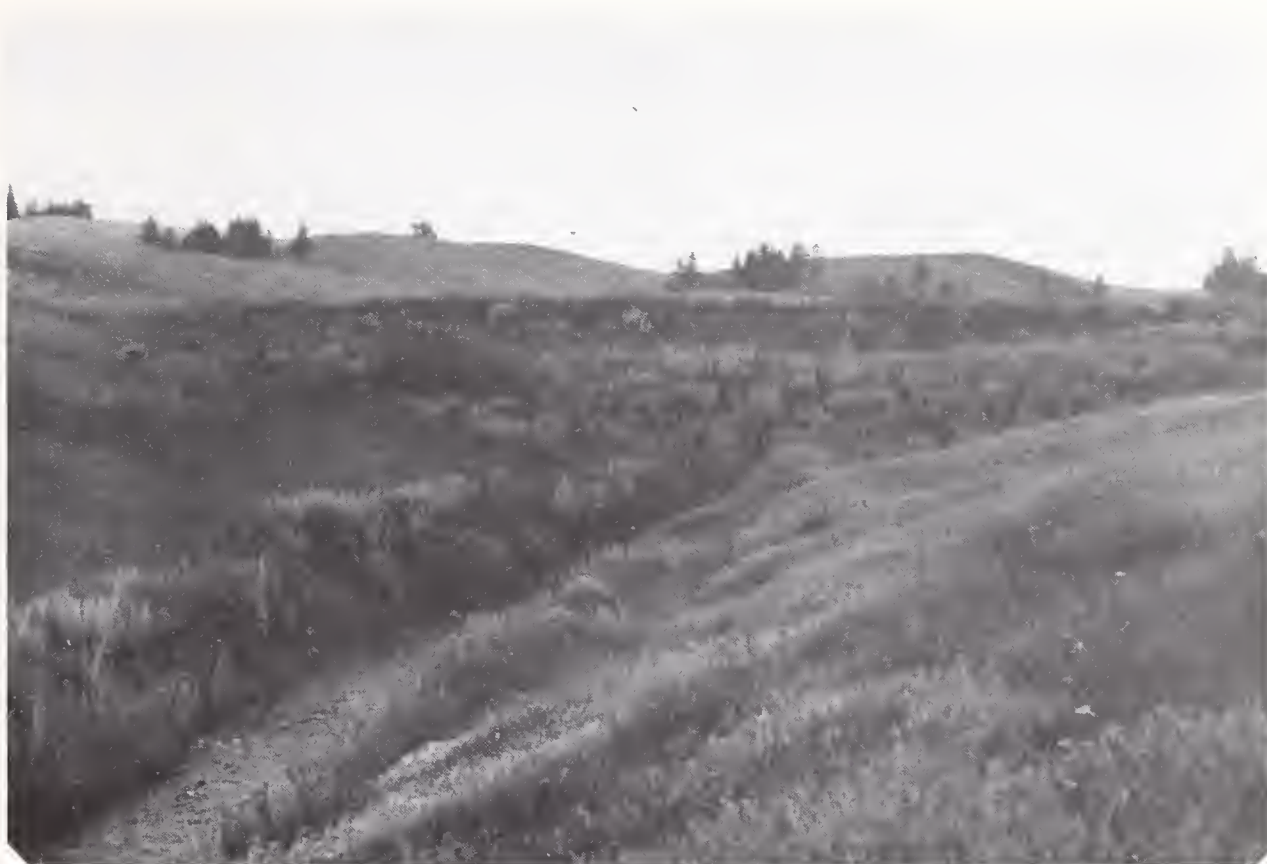
Photo 3 Downstream Face of Dam and Outlet Canal.

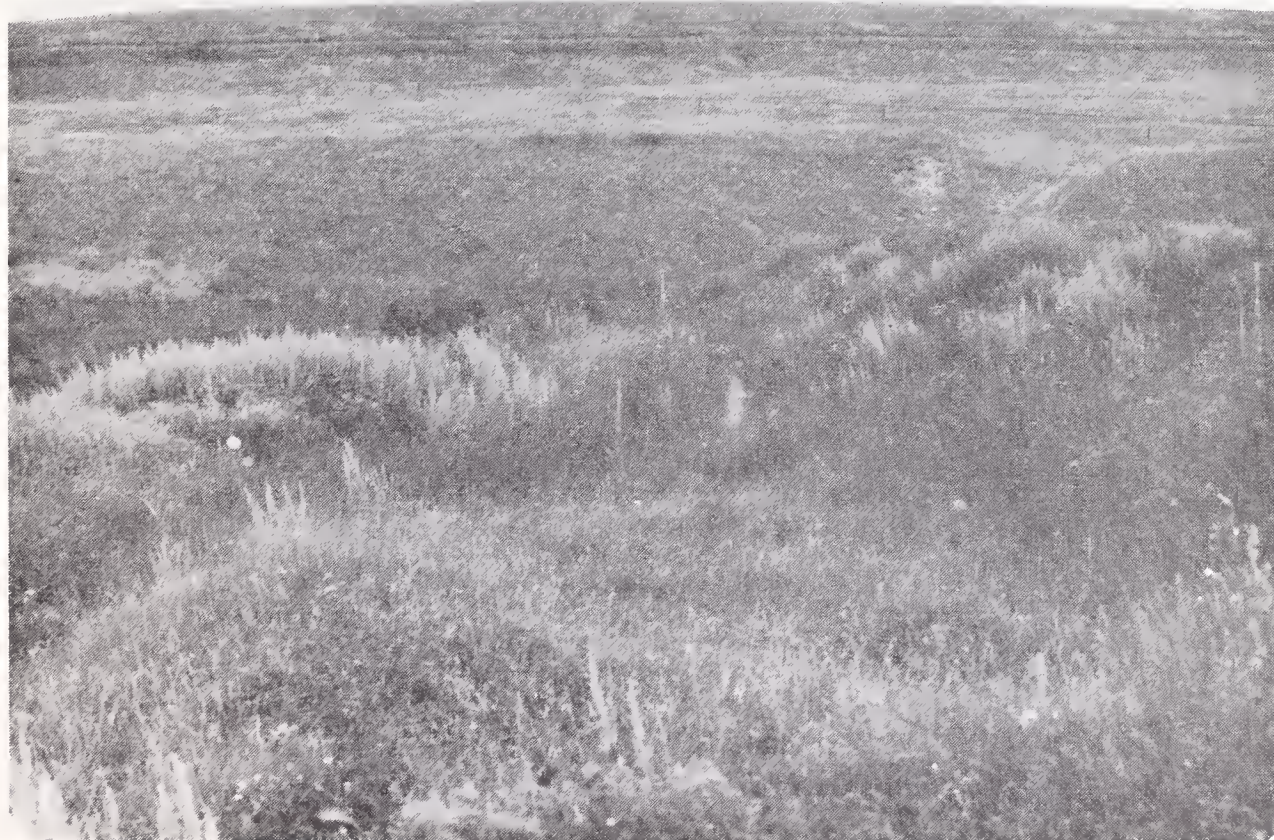
Photo 6 Added Bench on Downstream Face with Irrigation Ditch.
Photo Taken Looking East Across Dam Face.

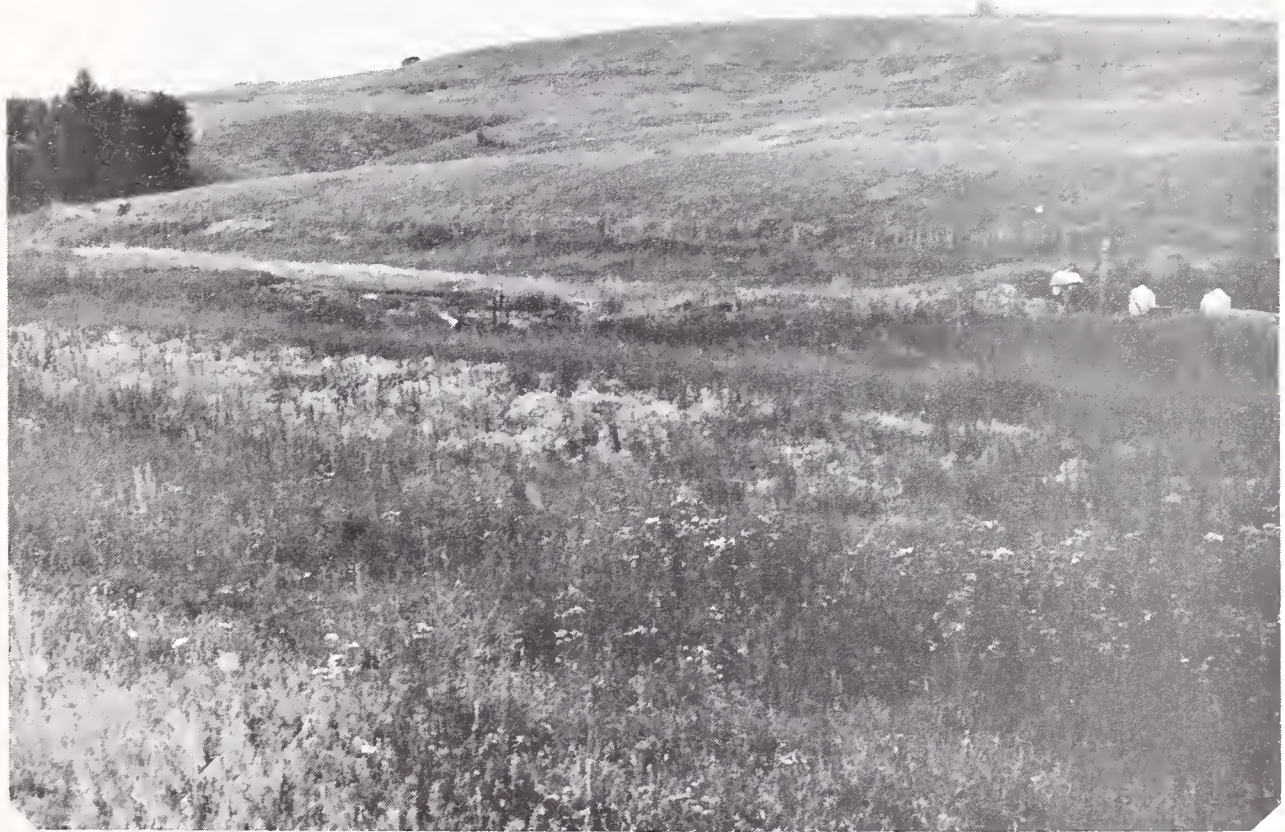
The project can handle a flood with a hydrograph having ordinates corresponding to 35 percent of the PMF ordinates before the main canal at the west dam abutment is overtopped. When the canal is overtopped at this location the dam abutment could erode and the stability of the dam is threatened. If the canal overtops at the second reach, approximately 750 feet from the dam, the canal embankment would fail and release water down a drainage west of the reservoir. Water released down the west drainage could cause loss of life at a house in the bottom of the ravine and then flow into the Costich Dam drainage upstream of Eureka. The safety of the project is therefore evaluated with regard to the overtopping condition of the main canal rather than overtopping of the dam. Because of the low canal embankment, the dam is not overtopped by the PMF. Because the project is incapable of controlling one-half the PMF without overtopping the canal embankment and causing the dam or the canal to fail, Costich Dam Project does not conform to inspection guidelines.

Photo 9 Main Canal Turnout to Ditch Across Face of Dam. Area of Potential Overflow Around West Dam Abutment.

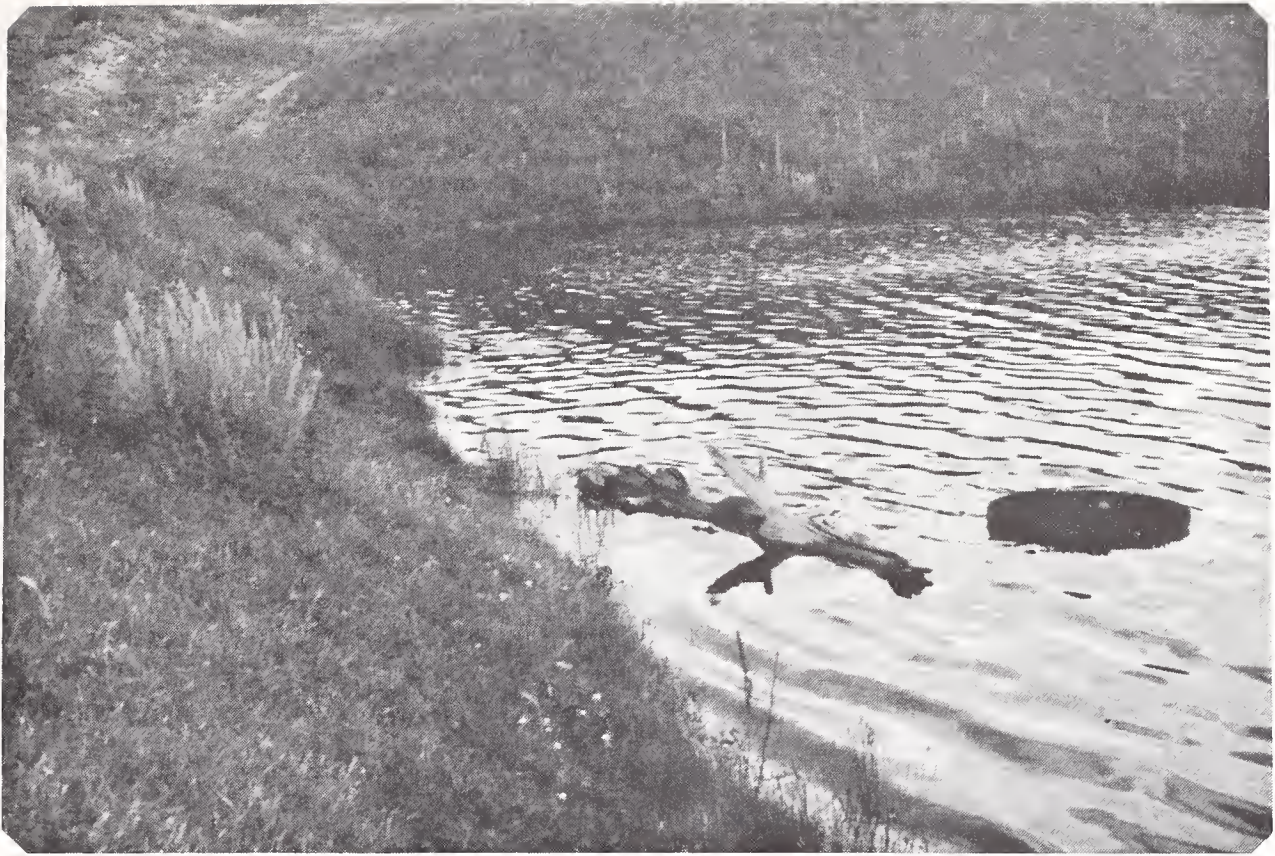
Photo 11 Principal Spillway Inlet.

3. Inspect the low-level outlet gate and conduit and repair as required.
4. Make an assessment of the phreatic surface through the embankments and their foundations by drilling and installing piezometers. Perform and place on file slope stability analyses of the critical sections. These analyses should be conducted by a qualified geotechnical engineer and be based on actual phreatic surface and strength characteristics as determined from piezometer drilling and sampling. Modify the embankment sections as required for stability.

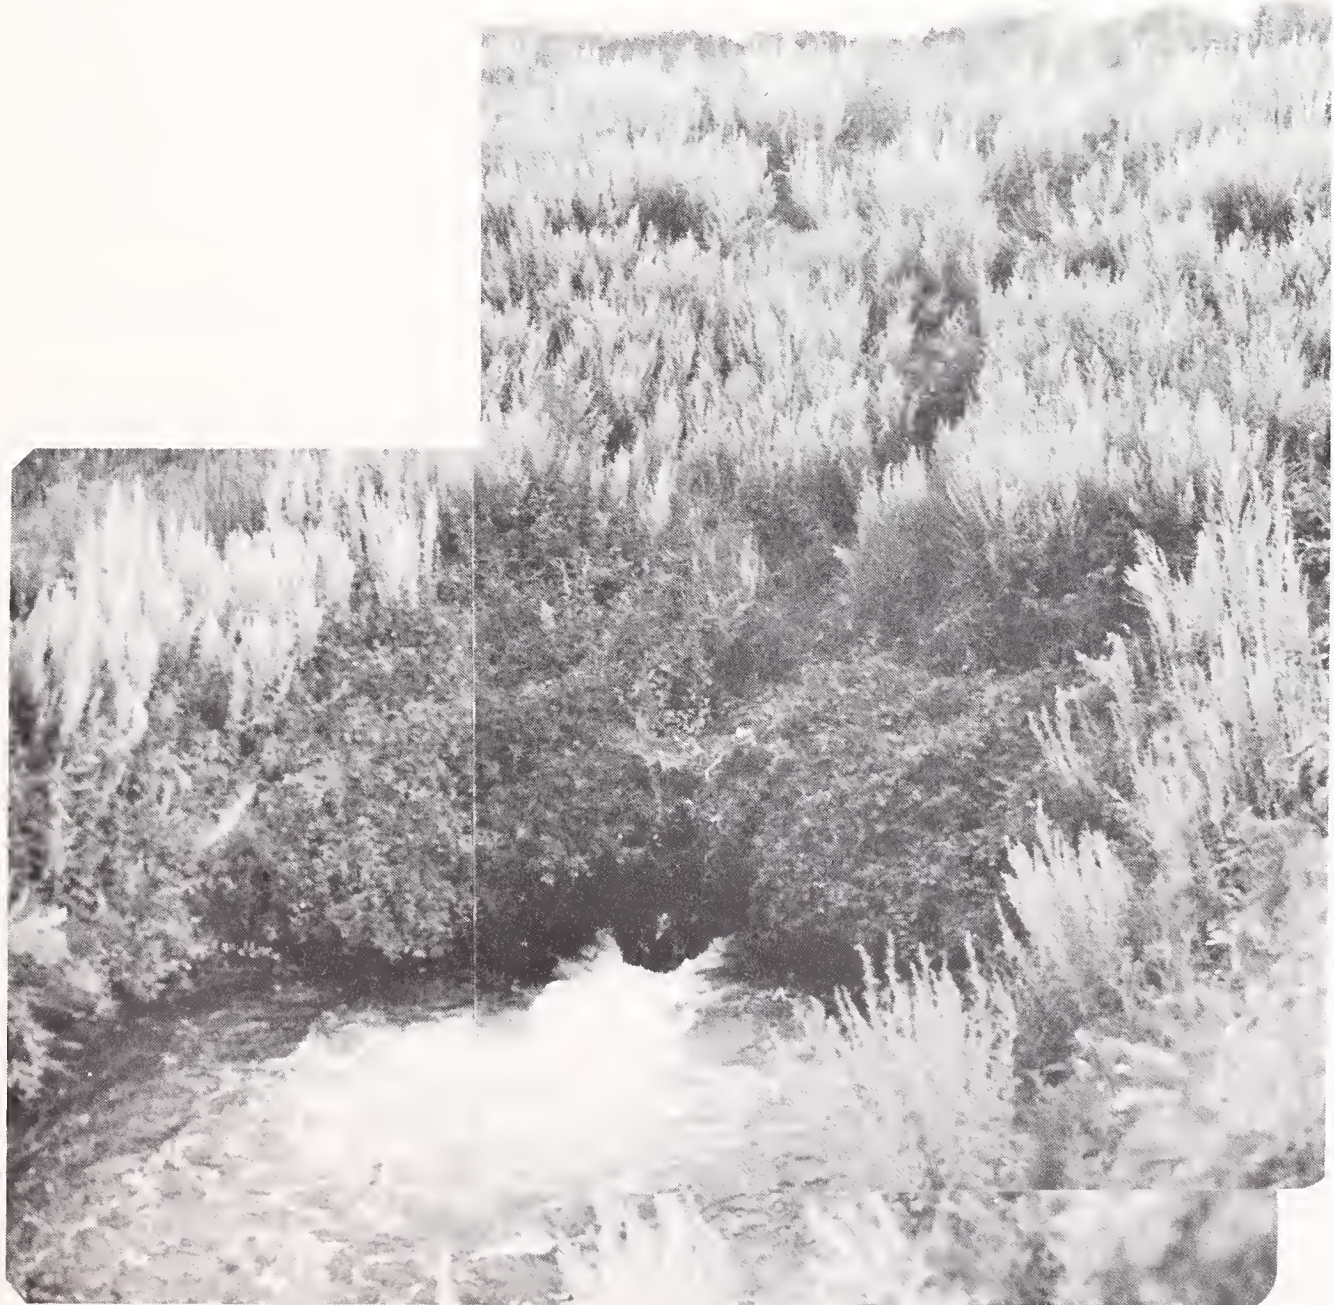
Photo 12 Outlet Pipe at Point of Discharge.
